## Northbound Lane of Highway 63, South of County Routes Y&M

**PRODUCT:** Joint Drain 7100-2

**APPLICATION:** PCC Joint Repair

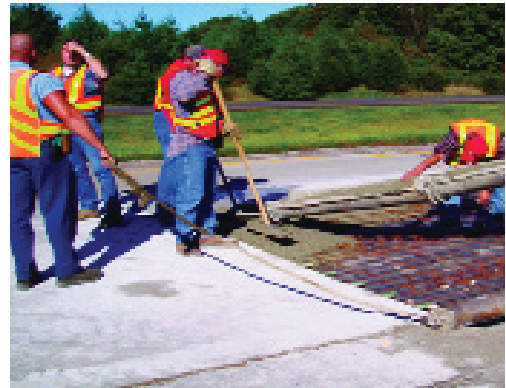
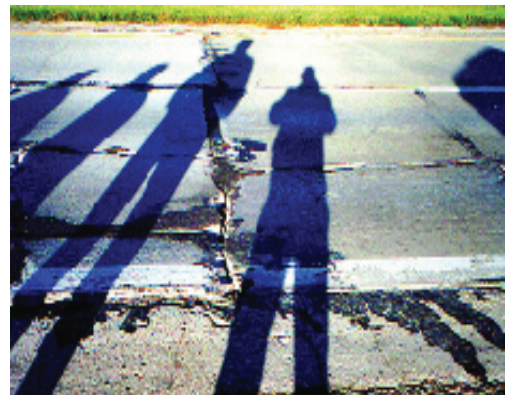
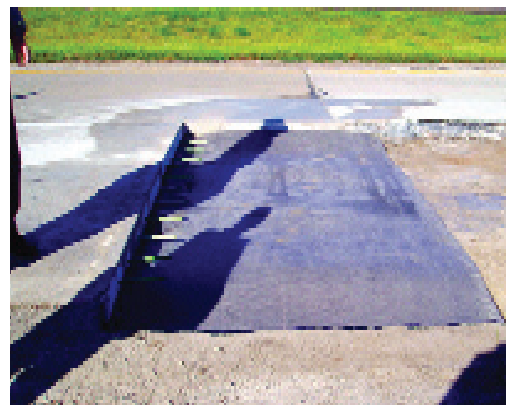
A 25 ft section of PCC pavement had shown considerable distress and needed to be repaired. Water infiltrating through the joints & cracks caused a loss of sub-grade support, decreasing the rideability.

The RoadDrain™ Geosynthetic Drainage Composite and an edge-drain system was selected to quickly drain water, while preventing the migration of sub-grade fines up through the PCC joints.

The entire "fix" took less than 2 hours to complete by the Missouri DOT Maintenance crew.
